# Front Facade Restoration Cambridge

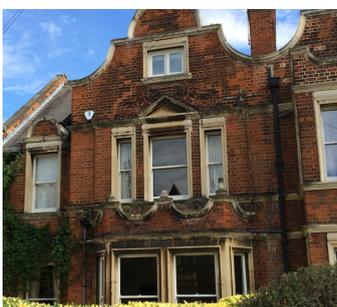
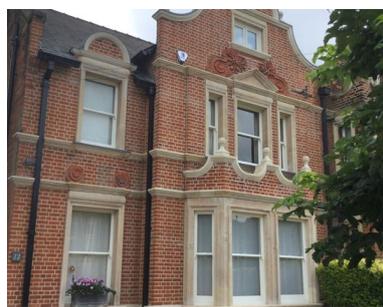
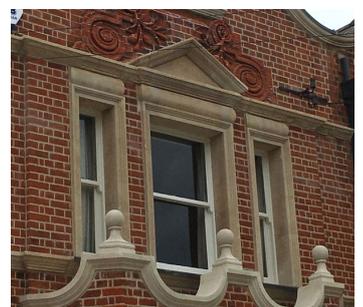
The stonework had generally lost its original moulded detailing but was still in a good structural state, however it was decided that the coping stones were in an unsalvageable condition so these were completely replaced.

The bay window had suffered from some historic movement and the parapet was in a particularly bad state of repair, therefore we partially dismantled the bay window and rebuilt it upright with new Bath Stone copings and finials.

The original Brickwork, which is of very high quality had been spoilt by bad previous brick repointing in various isolated locations. The decision was taken early on in the project that old jointing on the whole front facade would be carefully raked out and repointed in lime mortar. We have also replaced over 130 badly eroded and we have also replaced over 130 badly eroded and de-faced bricks in isolated areas with new handmade bricks to match the original. Two decorative carved brick panelled areas that were once spoiled by heavy carbon deposits have now been carefully cleaned and conserved with colour matched lime mortars. This has revealed detail that was previously hidden.

Firstly the whole front facade was lightly DOFF cleaned to remove the surface carbon deposit and allow us to see exactly what repairs would be required.

We managed to find enough detail on the original stone to replicate the original mouldings, these were then cut and worked in our workshops on Victoria Road and dressed in lead to prolong its serviceable life. The missing ornate finials were also reinstated.

Old unused service pipes were removed and the missing string course stones and brickwork were made and fitted. The rest of the string course stonework was de-frassed and made good with lime mortars and then Nano-particle sized, super-hydrophobicity was applied to all conserved surfaces.
