# Front Facade Restoration Cambridge

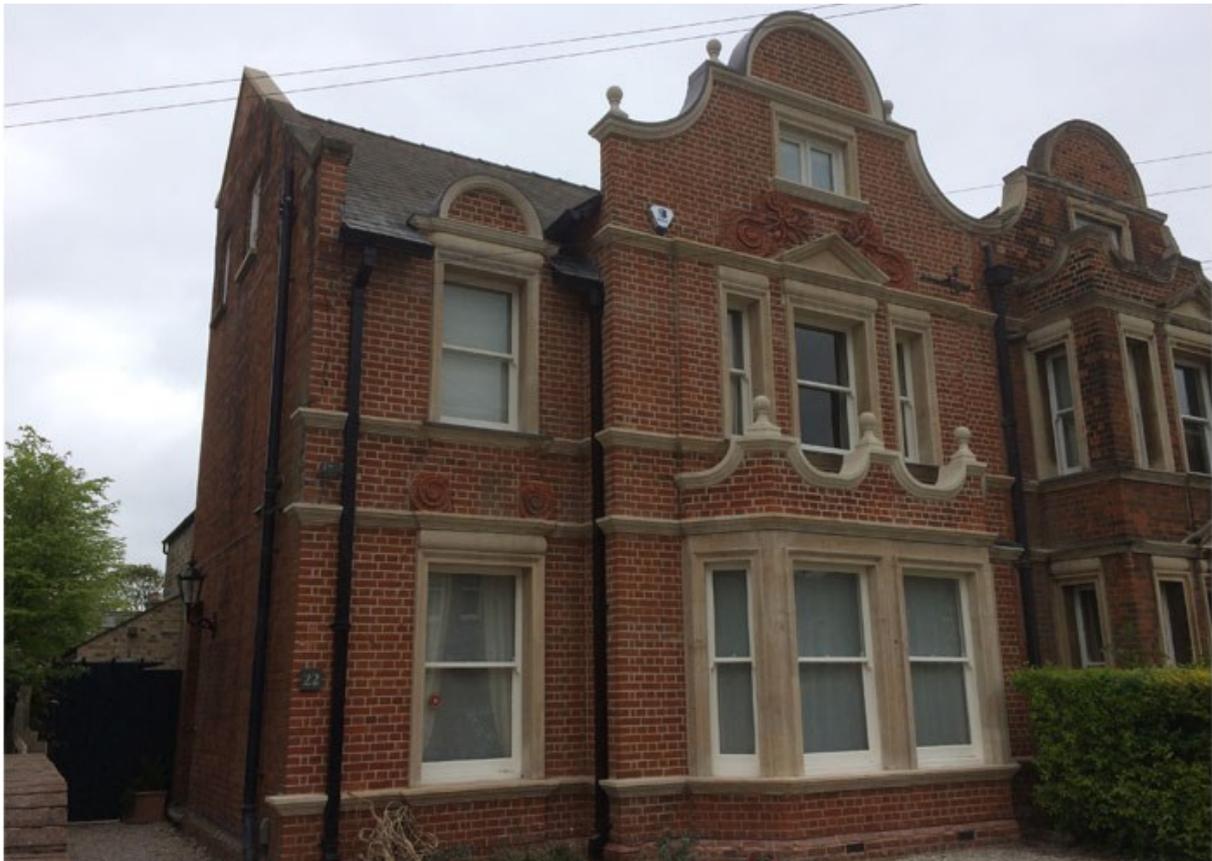
This stunning property in Cambridge, like many in the city, had lost some of its original aesthetic impact due to general decay, bad previous repairs and sacrifices its facade had made due to the poor implication of services during conversion work in the buildings past use as a multiple room let property.

Firstly the whole front facade was lightly DOFF cleaned to remove the surface carbon deposit and allow us to see exactly what repairs would be required.

The stonework had generally lost its original moulded detailing but was still in a good structural state, however it was decided that the coping stones were in an unsalvageable condition so these were completely replaced.

We managed to find enough detail on the original stone to replicate the original mouldings, these were then cut and worked in our workshops on Victoria Road and dressed in lead to prolong its serviceable life. The missing ornate finials were also reinstated.

Old unused service pipes were removed and the missing string course stones and brickwork were made and fitted. The rest of the string course stonework was de-frassed and made good with lime mortars and then Nano-particle sized, super-hydrophobicity was applied to all conserved surfaces.

The bay window had suffered from some historic movement and the parapet was in a particularly bad state of repair, therefore we partially dismantled the bay window and rebuilt it upright with new Bath Stone copings and finials.

The original Brickwork, which is of very high quality had been spoilt by bad previous brick repointing in various isolated locations. The decision was taken early on in the project that old jointing on the whole front facade would be carefully raked out and repointed in lime mortar. We have also replaced over 130 badly eroded and we have also replaced over 130 badly eroded and de-faced bricks in isolated areas with new handmade bricks to match the original. Two decorative carved brick panelled areas that were once spoiled by heavy carbon deposits have now been carefully cleaned and conserved with colour matched lime mortars. This has revealed detail that was previously hidden.
